Sunriver Owners Association - Tunnel Evaluation Report

March 2021

Prepared by: Century West Engineering

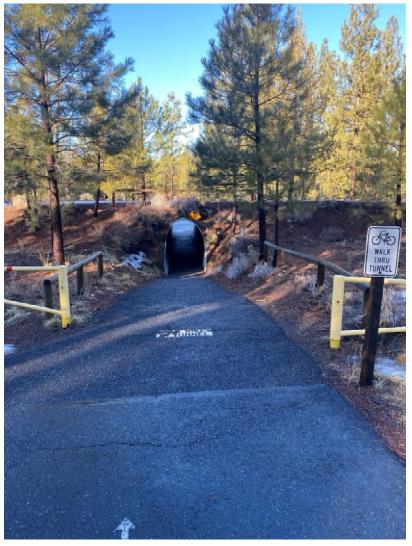
East Approach to Tunnel

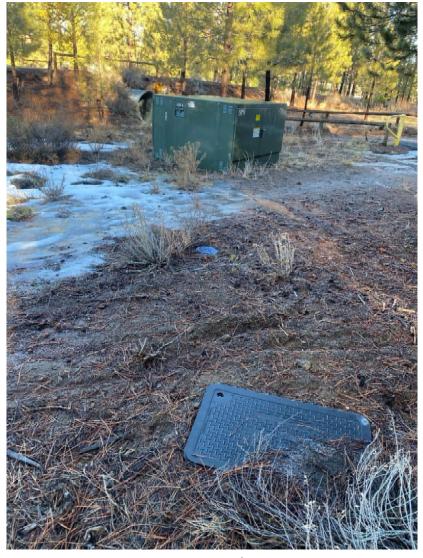
An existing water main along with multiple other utilities in the vicinity may provide a challenge when designing and constructing a tunnel at this location. Existing power, gas, and water utilities are visible on the east side of the tunnel.

Existing Utilities

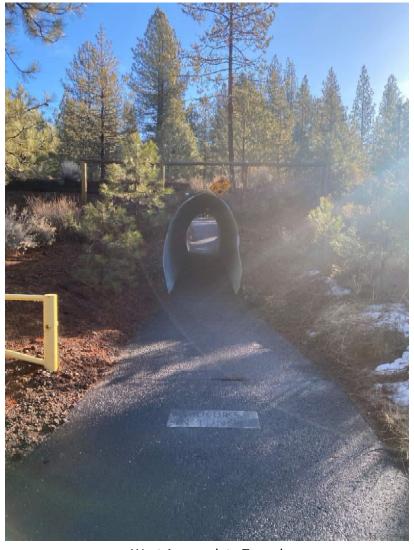
The existing tunnel is in good condition overall, with the exception of minor damage to the interior of the tunnel.

West Approach to Tunnel

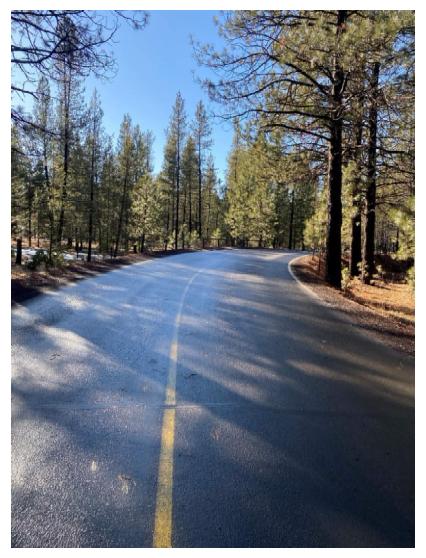
Crane access is expected to be somewhat challenging at this location due to the numerous trees surrounding the project site. The tunnels are located on a curved section of roadway which may create additional difficulties for crane operation.

Abbot Drive crossing Tunnels from North

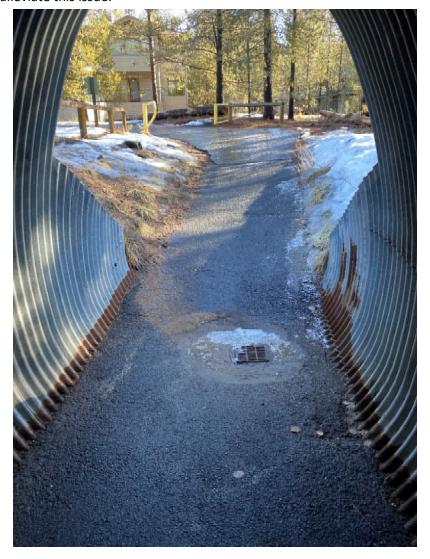
This location has significant stormwater and flooding issues. Pathways from both sides of the tunnel slope down to the tunnel, creating a ponding issue inside of the tunnel. Existing area drains have been placed on both ends of the tunnel to alleviate this issue.

Existing Area Drain

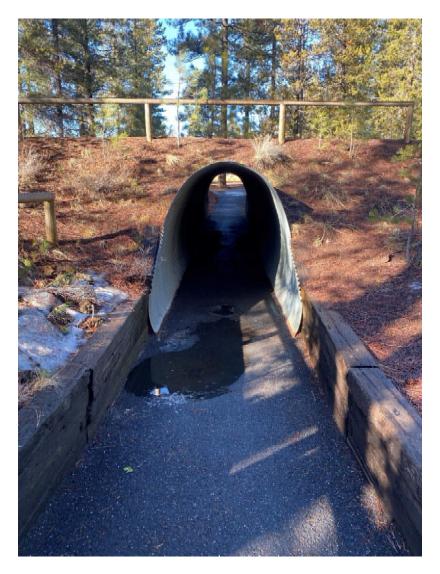
This location has significant stormwater and flooding issues. Pathways from both sides of the tunnel slope down towards the tunnel, creating ponding concerns inside of the tunnel. This tunnel has been identified by SROA staff as the 2nd worst location for flooding throughout the community.

Flooding Outside Tunnel Entrance

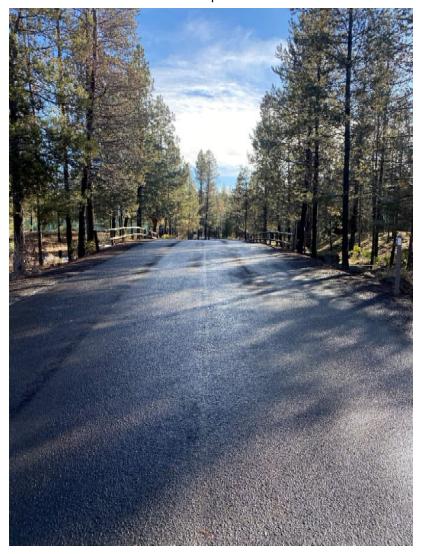
Crane access is expected to be a problem at this location due to the numerous amount of existing trees in close proximity to the tunnel.

Center Drive over Tunnels with Surrounding Trees

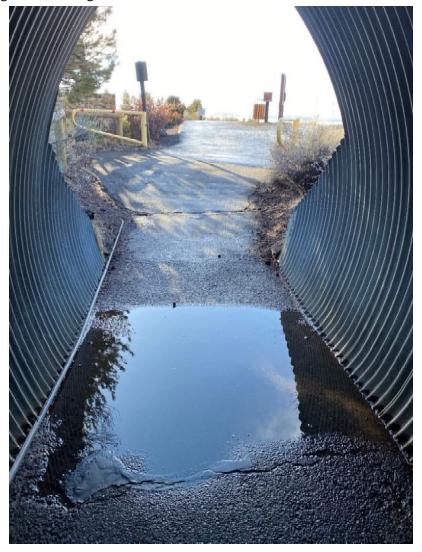
This location has significant stormwater and flooding issues. Ponding inside the tunnel is a common occurrence due to the steep grades entering the tunnel from the south.

Ponding & Steep Approach on South Side of Tunnel

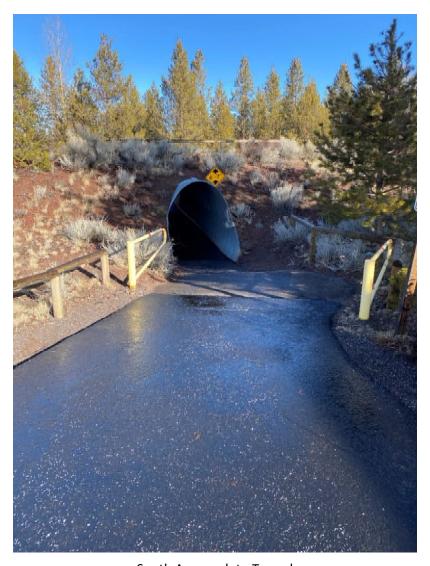
The existing tunnel has become "egg shaped" from exterior loads, however it appears to be in good condition.

South Approach to Tunnel

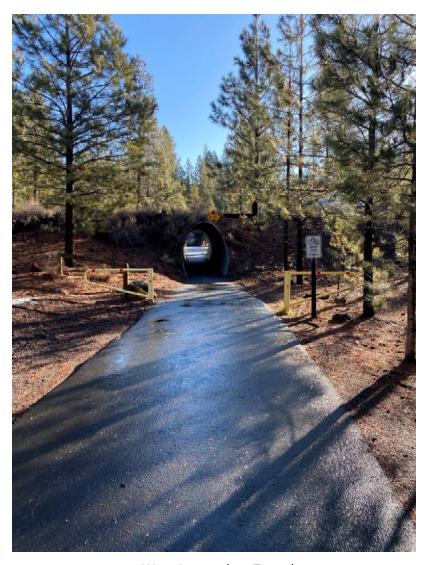
The existing tunnel is in good condition with only minor defects on the interior of the tunnel.

West Approach to Tunnel

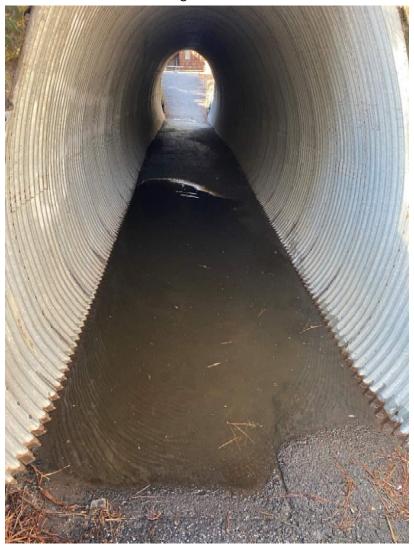
This location has severe stormwater issues due to the existing topography and slope of the pathways. SROA staff has indicated this is the worst tunnel for flooding.

Flooding Inside Tunnel

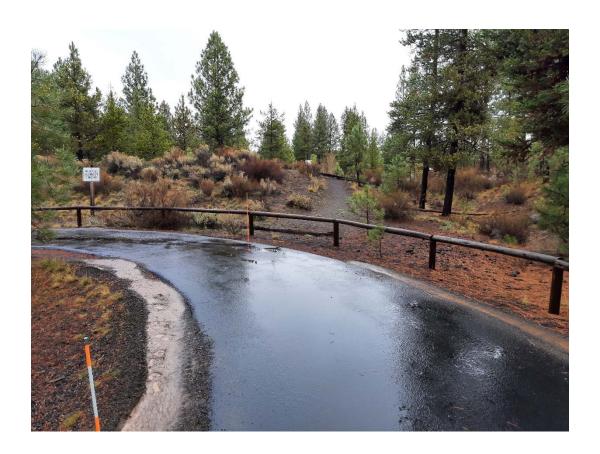
The south side of Theater appears to include a linear drainage swale adjacent the existing path. A similar small swale is included adjacent the vehicle access for the basketball overflow parking area. These drainage features would require replacement with a sedimentation manhole and drywell assembly, compliant with local and state stormwater management requirements.

Facing Approximate Proposed Tunnel Location from South Side of Theater
